Bulletin

SRN # S-0018
APC # 509, 448, 537, 225,
675,360
DATE: September, 2000
EXPIRES: NA

SUBJECT: Quantar RF Power Output Instability

MODELS AFFECTED: Quantar Station: T5365A

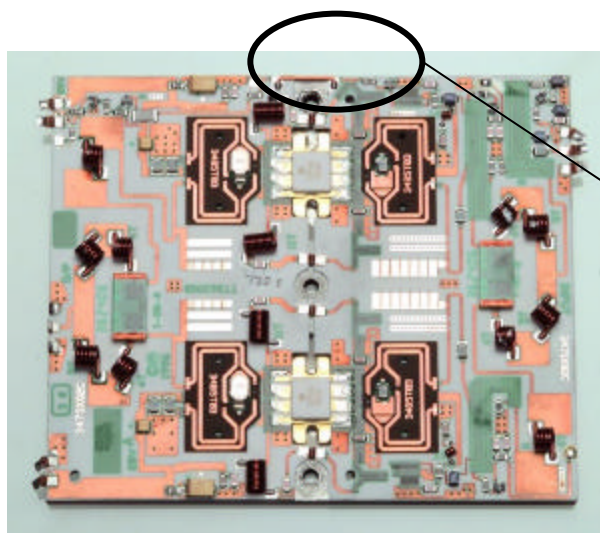
Figure 1

SYMPTOM: Fluctuations in RF power output may be seen on an RF wattmeter when the station is set at or near 60 watts and the station is programmed between 132 MHz through 174 MHz. Additionally, an audio oscillation may be heard in the receiving subscriber for approximately 4-5 seconds at the beginning of the conversation.

CAUSE: Incorrect dc bias voltage applied to the final stage of the RF driver.

RESOLUTION: This condition may be corrected by cutting the jumper wire (W598) (Figure 2) which is located on the TTD6390B module (Figure 1). It is suggested to remove the jumper wire by cutting each end and discarding the clipped section.
